## Safety Flash

### Near Miss Incident

Date of Incident: 12/12/2018

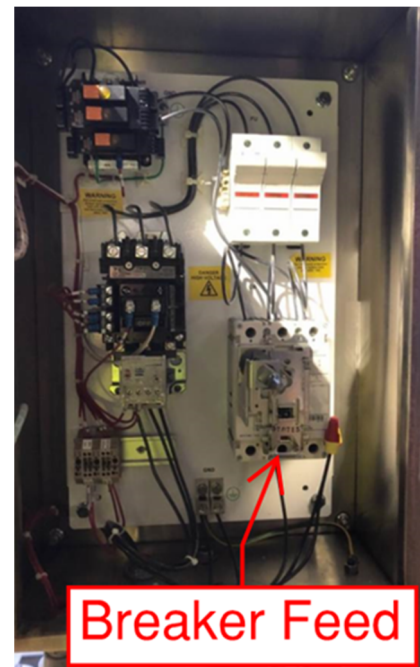
While replacing a motor on a blower skid, an associate discovered that the new motor rotation needed to be reversed. When he attempted to reverse the wires, he received an electrical shock.

- The breaker in the OEM-supplied cabinet is bottom-fed. The industry standard is typically top-fed.
- Per the customer requirements, the outside of the cabinet should have been labeled to identify the bottom-fed breaker.
- The associate failed to verify that the wires were de-energized before starting work.
- The crew felt rushed because they were informed late in the day that they needed to complete their work by the end of their shift.

- Always verify that the equipment has been de-energized and locked out before starting work.
- "Take 2" for safety and evaluate your work area for unusual conditions and/or potential hazards.
- Discuss the work plan with your coworkers to identify hazards.

- A safety stand-down was performed with all associates on site.
- Safe electrical work practices were reviewed with the crew.
