Safety Flash

Incident with Recordable Injury

Date of Incident: 9/27/2021

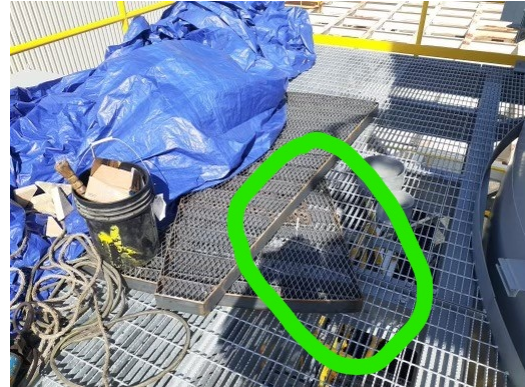
An associate was handed a porta-power by another associate working in the same area. The associate stepped backwards and pivoted to his right to transport and deposit the porta-power elsewhere. The associate's right foot landed on a staged piece of grating (circled in green at right) that caused his ankle to roll to the outside. This resulted in a high ankle sprain that required medical treatment beyond first aid.

- Congested work area on a piece of equipment (what was being installed) on the roof.
- All components of the equipment were lifted to the roof on a Saturday by a mobile crane, and the crane would not be back on site until demobilization. This limited the amount of time and space for staging the components for ease of installation.
- Material/components were staged but not well organized. Material/component lifts to the roof were lifted as shipped and not reconfigured for easy staging to maintain housekeeping standards.

- Take 2: to reconfigure material lifts, stage to eliminate slips, trips, falls
- More detailed plan to address sequence of the lifts and organization for staging
- Pre-Lift Meeting to include details of how to stage materials

- Peer reviews on STAC completion and quality
- Review Pre-Task Plans with entire crews and discuss unaddressed hazards
