## Safety Flash: Incident with Recordable Injury

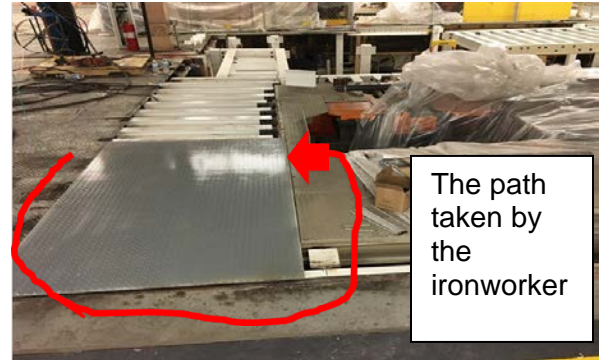
**Incident:** A crew was installing floor plating around a toe-in alignment machine that had been placed into an existing 7-foot-deep pit. The first plate did not sit correctly in the opening. An ironworker walked around the plate to move it into position. As he was using a bar to move the plate, he stepped backward, falling into the Visqueen-covered opening on the deck of the alignment machine. He caught himself on the side of the opening, injuring his right side.

- When the equipment was covered with Visqueen on the ground, workers did not recognize the potential fall hazard once the equipment was set in place and did not protect the opening.

- When planning work, be sure to address existing and future conditions, such as fall hazards, pinch points, etc. that are created by construction or equipment installation.
- Educate all workers on fall protection requirements and methods.
- Use Personal Fall Arrest Systems within 15 feet of an opening or edge that is not protected by a fall protection system.

- Investigate changing owner document to address hazards introduced due to construction and equipment installation.
- The contractor immediately conducted a stand down with the toe-in alignment crew to go over fall protection requirements. A second stand down was conducted with the remaining crews on site.
- The openings in the toe-in machine were covered, marked and secured in place.
- The pre-task analysis was revised to address the covering of openings in the toe-in alignment machine.
