Safety Flash

Recordable
Date of Incident: 8/18/2017

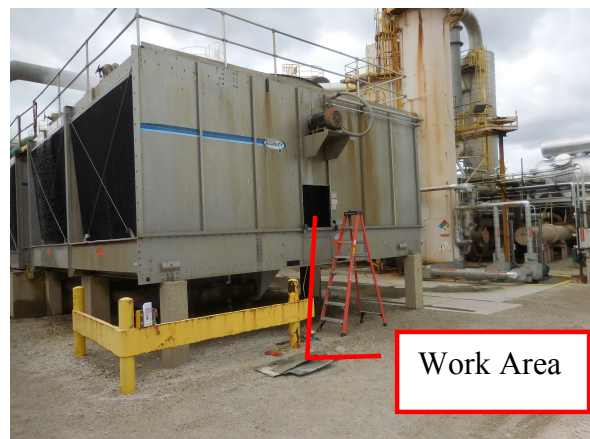
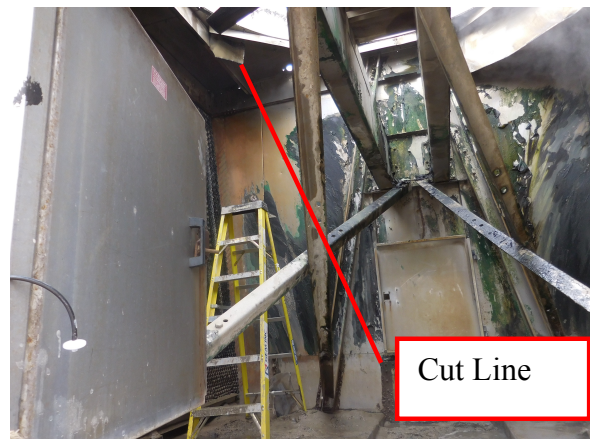
An associate was holding a stepladder while another associate was cutting a piece of shroud that was being hit by a fan blade. When the associate cut through the shroud, the piece fell down striking the other associate on his right arm at the base of his bicep. The incident caused a laceration that required sutures.

- The stepladder was not secured in place so a second associate had to hold the ladder in place while the other associate cut the piece of shroud.
- The associate on the ladder did not secure the piece of shroud when he cut it free causing it to fall and hit the other associate on the arm.

- The stepladder should have been secured by other means rather than the associate holding it in place.
- Instead of working off of a stepladder a scaffold deck could have been erected.
- The piece of shroud that was cut free should have been secured from falling.

- Material handling presents many hazards. Review the STAC to address the hazards associated with falling objects.
- Reaffirm the "360" process to be proactive to potential hazards that could be created while performing a task.
- Communicate this "Lessons Learned" company wide.
