SAFETY MATTERS

JANUARY/FEBRUARY 2022

HOLLYWOOD CASINO GAMING TERRACE

PELOTON OUTPUT PARK

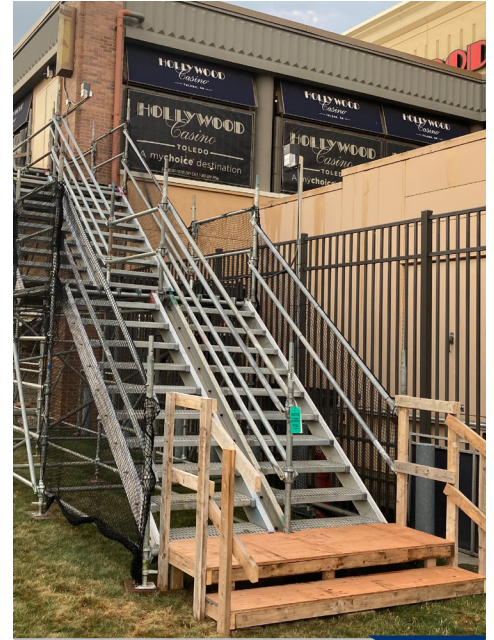
The casino egress stairway

The temporary egress stairway was an important precaution

During Phase 1 of the gaming terrace construction, three sets of double doors needed to be closed in the casino.

That created an issue: Temporary main egress was required for patrons and casino employees.

GEM installed electrical and lighting for the stairs and landing. RLI installed temporary doors from the porch and the stairway.

To provide side protection, nylon netting was secured to the handrails and guardrails to meet code for falling objects.

The stairs were installed and ready for use in late August when construction began on the addition. The stairs never needed to be used, but they were an important precaution.

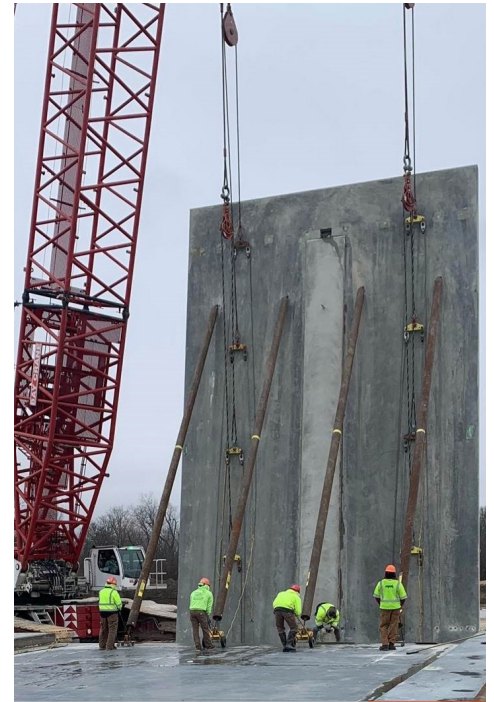
The largest, heaviest panel being lifted into place

The lifts of 288 panels - most averaging 125,000-130,000 pounds and measuring about 20 feet by 45 feet - went perfectly.

The lift included our largest, heaviest-ever tilt-up panel - 217,000 pounds and 50 feet by 30 feet - hoisted into place with a 650-ton crane.
