Safety Flash

Incident with property damage

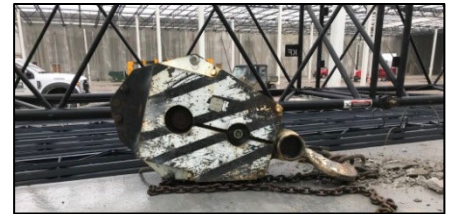
Incident: A subcontractor and crane supplier reconfigured an onsite crane for a 2-line lift by removing boom sections and adding a second line. A post-assembly inspection was completed and documented. The next day, the operator inspected the crane and hooked rigging to pick a precast concrete panel. As the operator began hoisting the cable, the wedge and cable pulled through the socket attaching the end of the cable to the boom. The 1,626-pound block fell, damaging the panel. There were no injuries.

The crane block

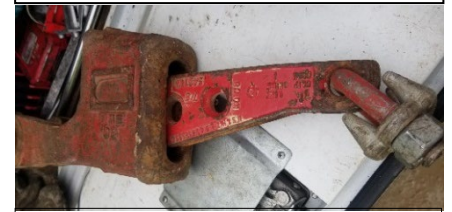
- Even though the wedge and socket were labeled for 7/8-inch cable, the pieces did not match.
- Multiple models of socket and wedge assemblies for the same size cable were stored on the crane, but matching socket/wedge assemblies were not secured as a set.
- The assembly crew did not realize that components of different model wedge/socket assemblies for the same size cable were not interchangeable.

The assembly crew did not realize that components of different model wedge/socket assemblies for the same size cable were not interchangeable.

Wedge and socket

- Make sure matching wedge/socket assemblies are clearly identified and stored/secured together as a set.
- Consider posting a sign on the crane about proper wedge/socket assembly.
- Communicate to operators and mechanics the importance of verifying that wedge and socket pieces match during assembly.

- The crane supplier began identifying matched sets of wedges and sockets, and ensuring they are stored as matched sets the day after the incident, and will recommend that all branch offices implement this program.
- The crane supplier and subcontractor will send a companywide email notifying all employees of the incident, solutions and action plan by February 15, 2019.
- RLI will share this Safety Flash with all crane suppliers and subcontractors that use cranes on our projects.
- The crane supplier is developing a sign to post on each crane, reminding workers to ensure the use of matching wedges and sockets.

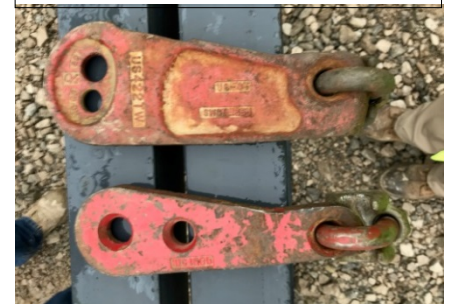
Different sizes of wedges
